Field Manual for post-earthquake damage and safety assessment and short term countermeasures (AeDES)

Translation from Italian: Maria ROTA and Agostino GORETTI

Editors: Artur V. PINTO, Fabio TAUCER

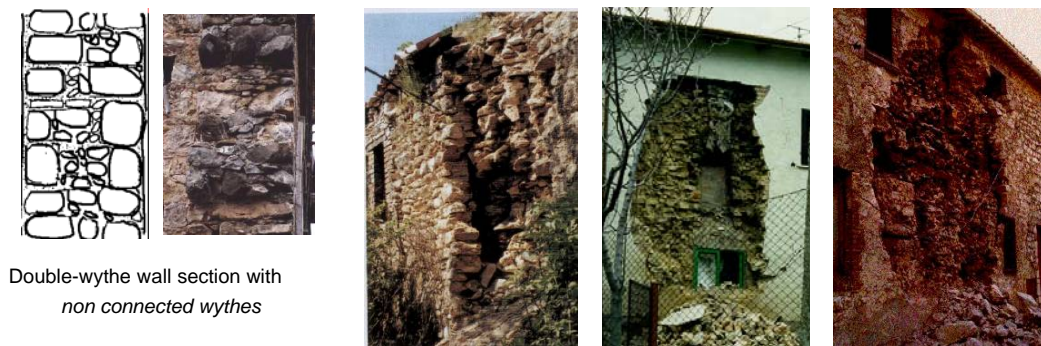
Fig. 3.2 Masonry wall with non connected or badly connected wythes, as highlighted by the disastrous collapses due to the earthquake (Ps)

- *the wall section* (III° level of knowledge), distinguished in the two cases of masonry with *well connected wythes* (Pc) and *disconnected or not well connected wythes* (Ps; it is the case of many types of poor ‘a sacco’ masonry). In post-earthquake surveys, the section geometry can often be observed in partially collapsed buildings. Some typical cases are reported respectively in Figure 3.1 and 3.2.

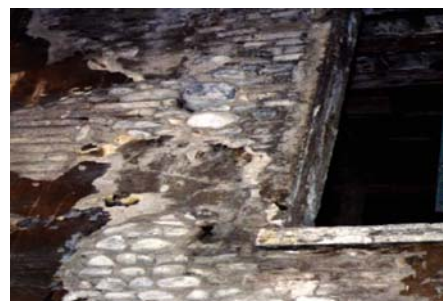
I			
M _c		M _b	
I		I	
P _s	P _c	P _s	P _c
I	I	I	I

Sassuolo (MO): pebbles and bricks

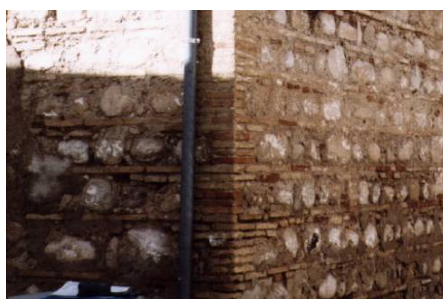
I			
M _c		M _b	
I		I	
P _s	P _c	P _s	P _c
I	I	I	II

Cast. dei Sauri (FG): Rubble stone masonry with brick courses

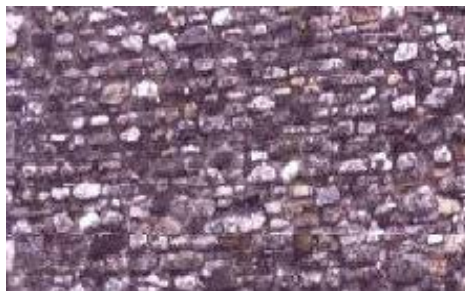
I			
Mc		Mb	
I		I	
Ps	Pc	Ps	Pc
I	I	I	I/II

Benevento: rubble stone with fairly regular layout

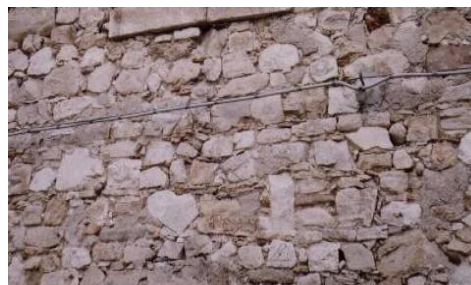
I			
Mc		Mb	
I		I	
Ps	Pc	Ps	Pc
I	I	I	I/II

San Angelo Limosano (CB): rubble stone with irregular layout

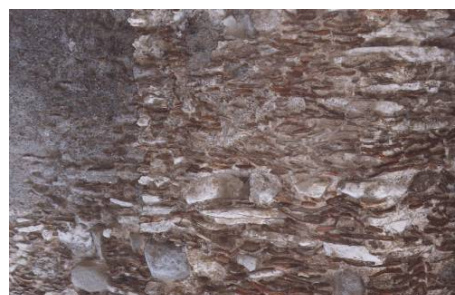
I - II			
Mc		Mb	
I		I/II	
Ps	Pc	Ps	Pc
I	I/II	I	II

Alia (PA): irregular masonry with flat tiles and limestone

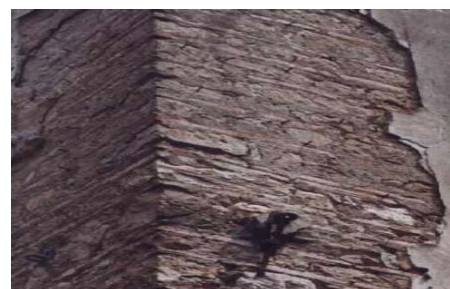
I - II			
Mc		Mb	
I		I/II	
Ps	Pc	Ps	Pc
I	I/II	I	II

Benevento: rubble stone masonry with brick courses

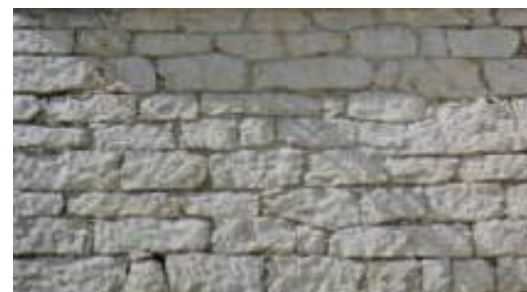
Mc		Mb	
I/II		I/II	
Ps	Pc	Ps	Pc
I	II	I	II

Cerchiara (CS): semi-dressed calcareous stone

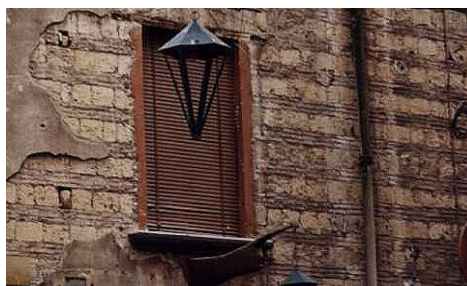
Mc		Mb	
I/II		II	
Ps	Pc	Ps	Pc
I/II	II	II	II

Napoli: volcanic tuff and bricks

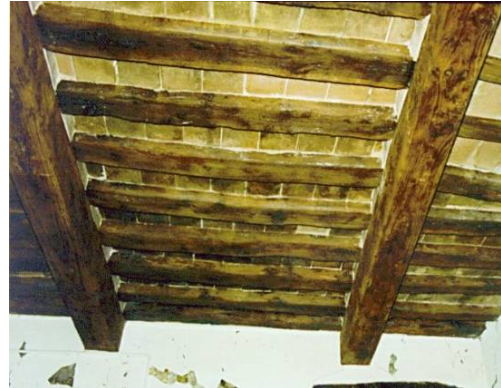
Wooden floor with clay tiles

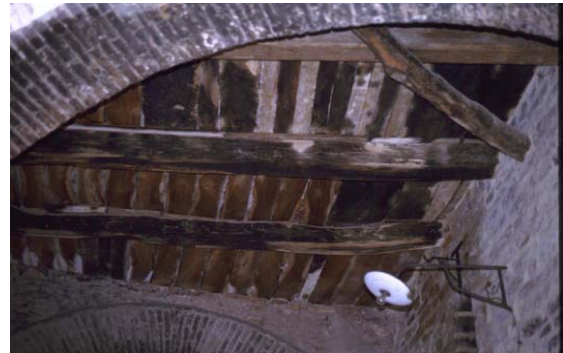
Wooden floor with wooden planks in a single direction

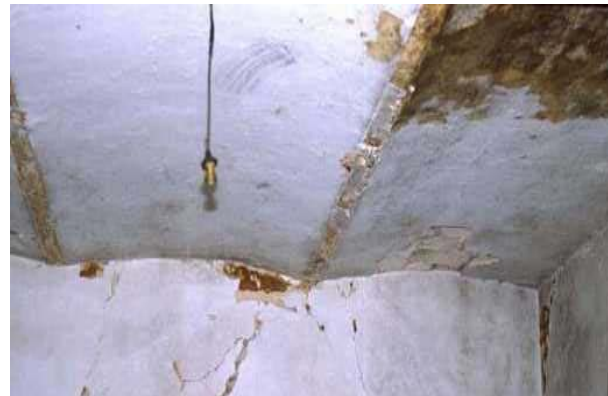
Floor with iron beams and shallow arch vaults

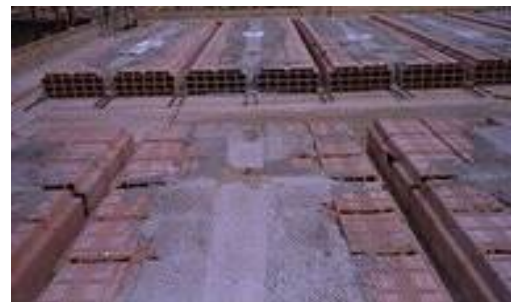
Floor of hollow clay tiles with cast-in-place concrete joists and topping

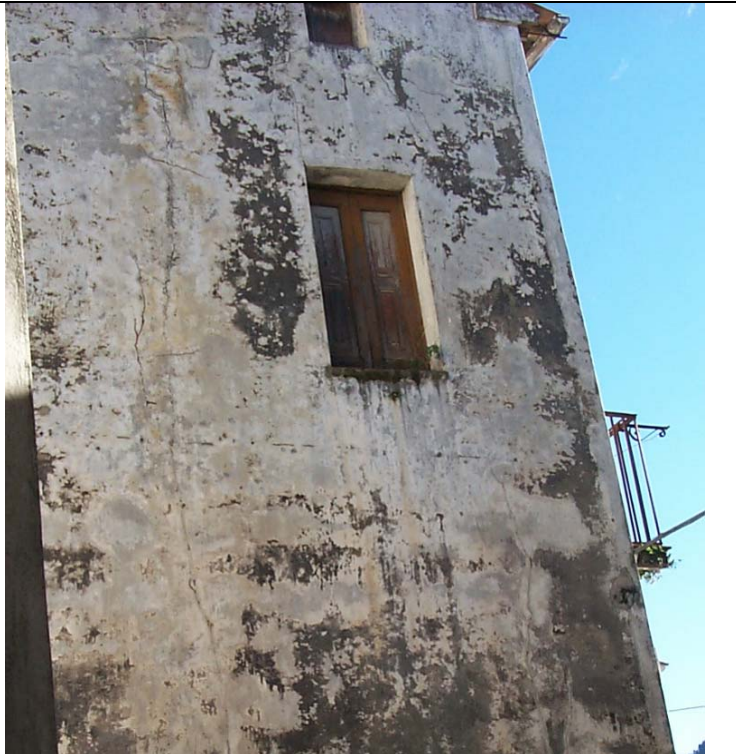
Fig. 4.3
Vertical (type 1) and diagonal
(type 2) cracks in the lintel.
Propping has been inserted.
Damage grade: D1

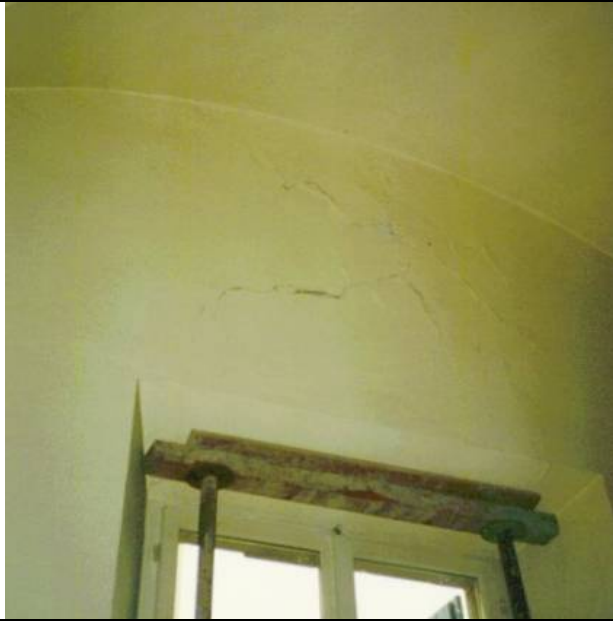
Fig. 4.4
Vertical cracks along the two
orthogonal walls (type 6)
Damage grade: D1

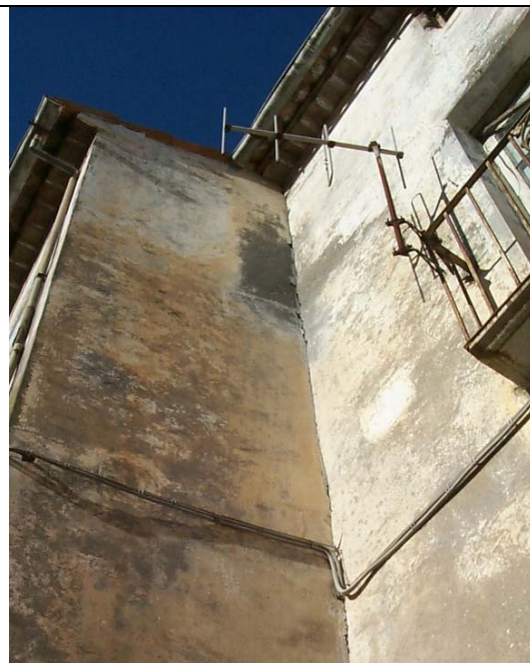
Fig. 4.5

Pre-existing out of plumb in a building located in the historical centre. Pre-existing damage grade for the building: D1

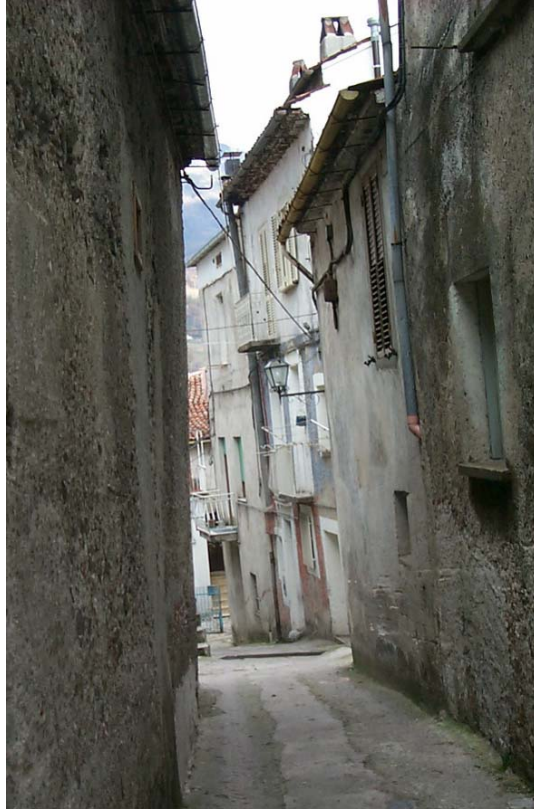
Fig. 4.6

Vertical cracks and separation from the adjacent building (type 7); diagonal and horizontal cracks (type 3) at the floor level (type 11); partial collapse of the roof and of the walls supporting the roof.

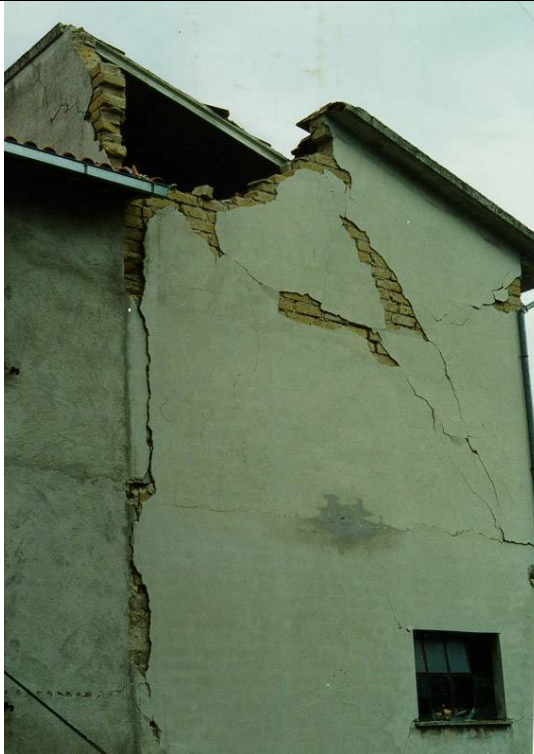
Fig. 4.7

Widespread vertical (type 1) and diagonal (type 3) cracks; almost horizontal crack (type 11) at the level of the attic. Damage grade to walls: D3 to be associated to the entire wall.

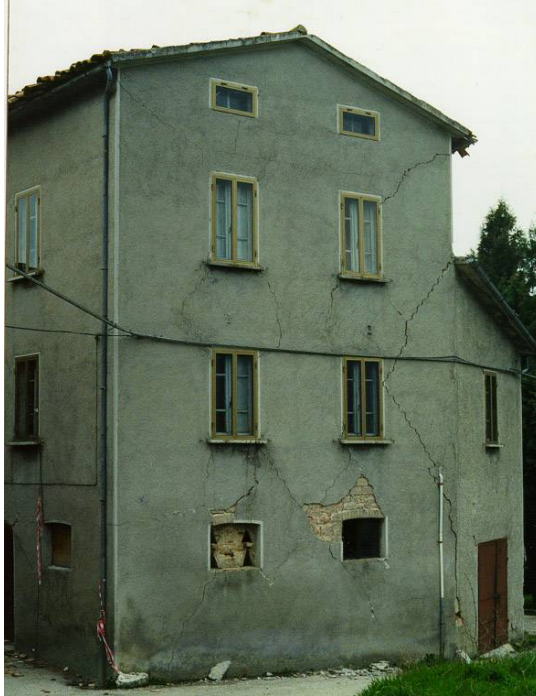
Fig. 4.8

Diagonal cracks in the second storey masonry piers (type 3), connected to horizontal cracks (type 1); on the right, a large masonry wedge, displaced by more than 10 cm, can be noticed

Damage grade: D4.

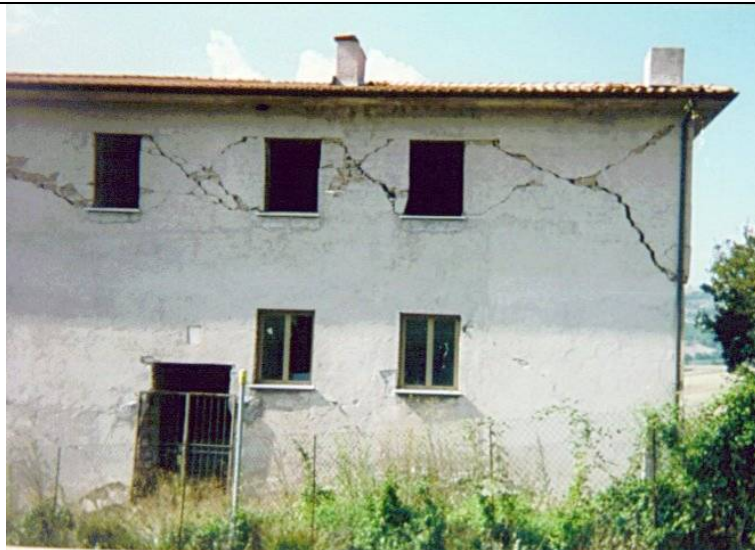
Fig. 4.9
Diagonal crack (type 3) in a
masonry pier, with dislocation
at the base.
Damage grade: D3, not far
from D4

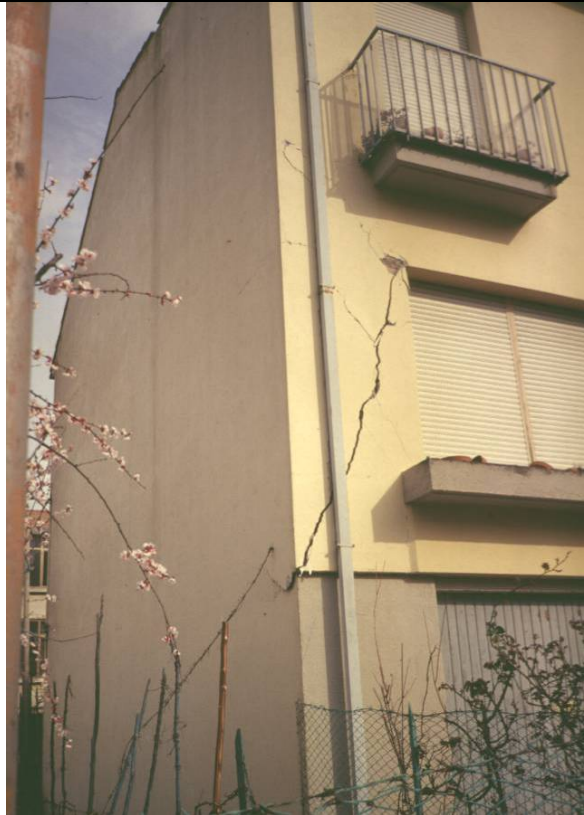
Fig. 4.10
Vertical crack with separation
of the orthogonal walls (type
7).
Damage grade: D2-D3

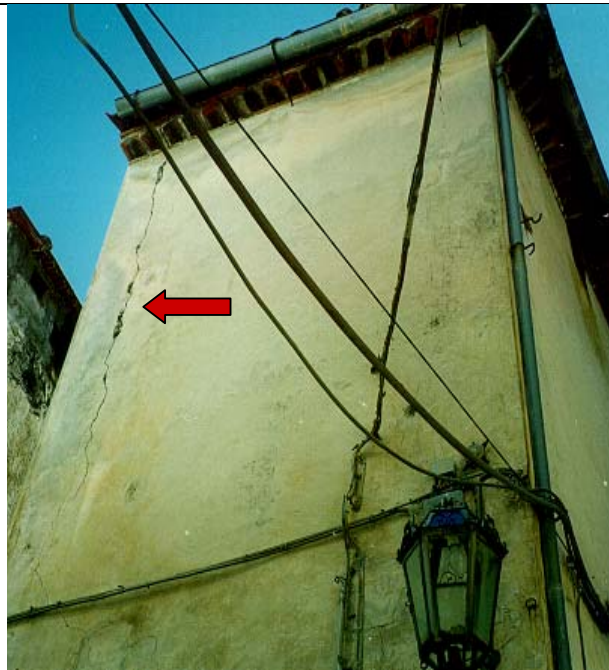
Fig. 4.11
Interior cracks with separation
of the orthogonal walls at the
corner (type 7)
Damage grade: D2-D3

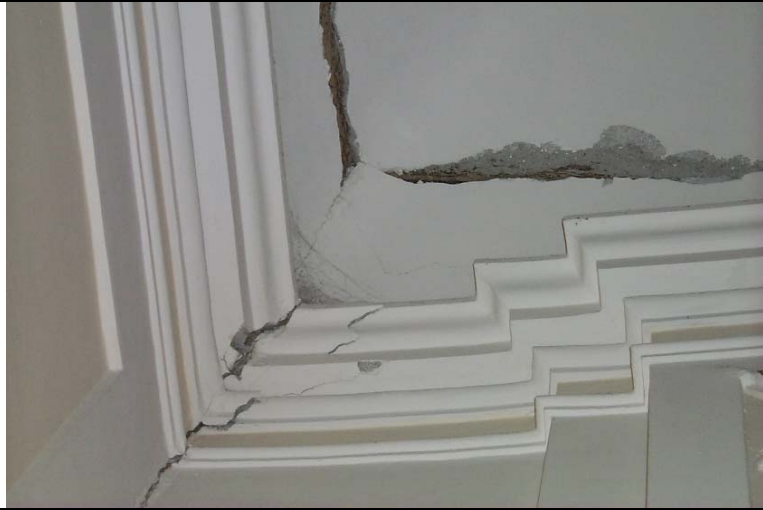
Fig. 4.12
Vertical cracks with
separation (type 7) of
orthogonal walls.
Damage grade: D3 not far
from D4

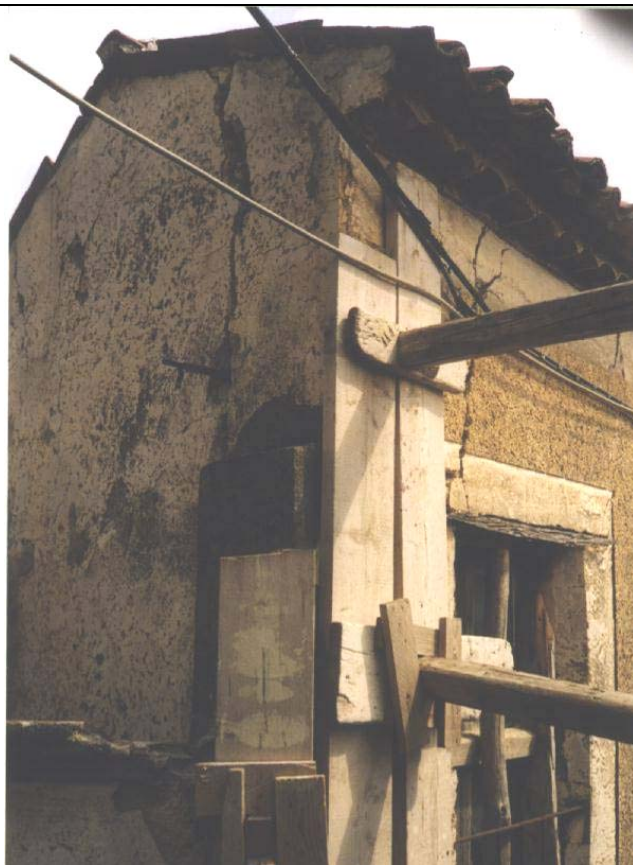
Fig. 4.13

Crack with separation of the
attic corner (type 9)

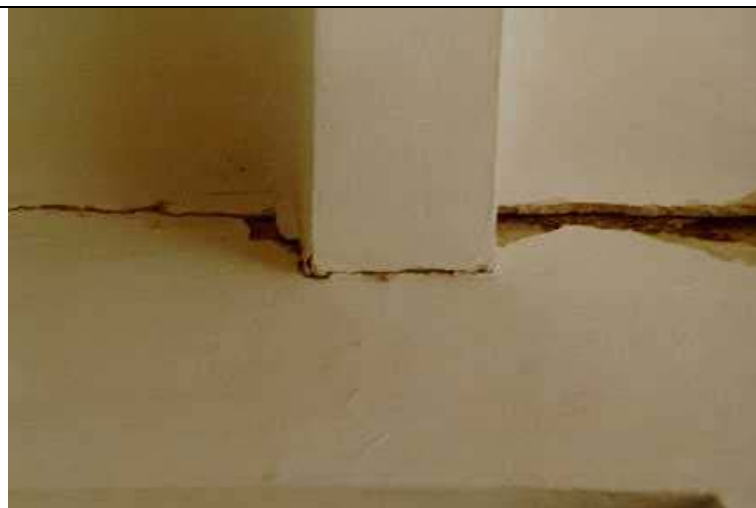
Fig. 4.17
Cracks on brick stretcher bond
vaults with tie rod.
Damage grade to horizontal
structures: D2-D3

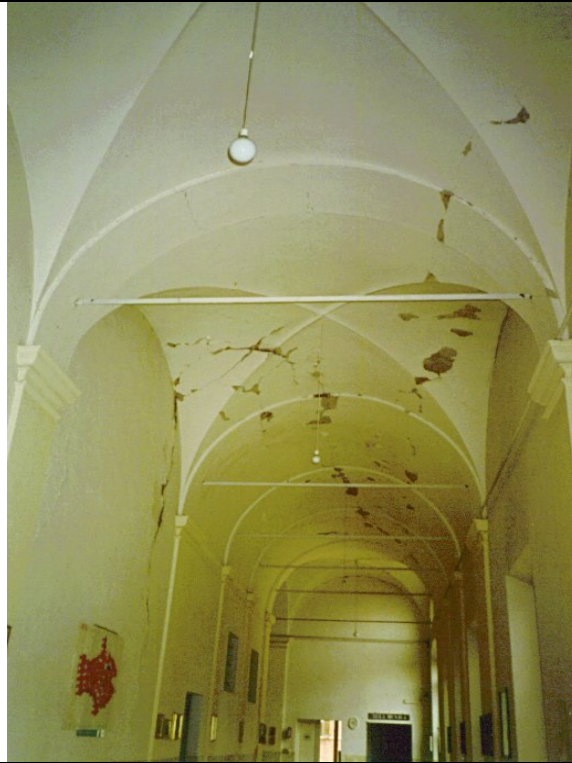
Fig. 4.18
Longitudinal crack at the
keystone of a cross vault and
separation from the gable.
Damage grade to horizontal
structures: D2-D3

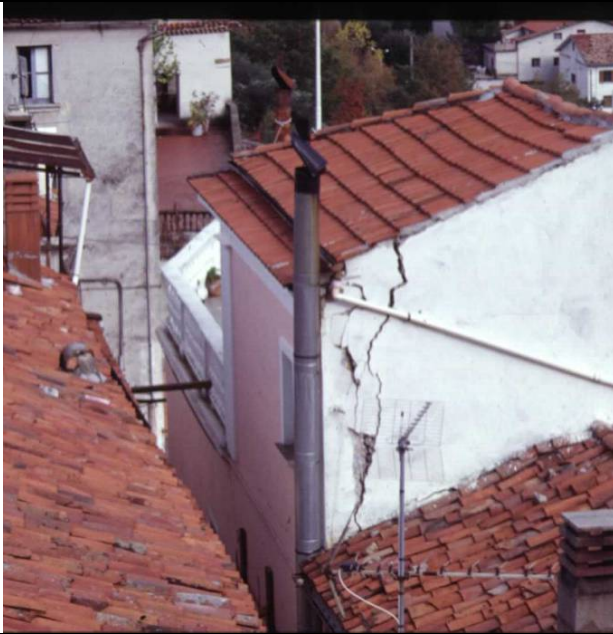
Fig. 4.20

On the left, vertical cracks due to wall separation (type 7); on the right, diagonal crack (type 3) on the masonry pier.

Masonry is made of tuff units.
Damage grade to the wall: D3

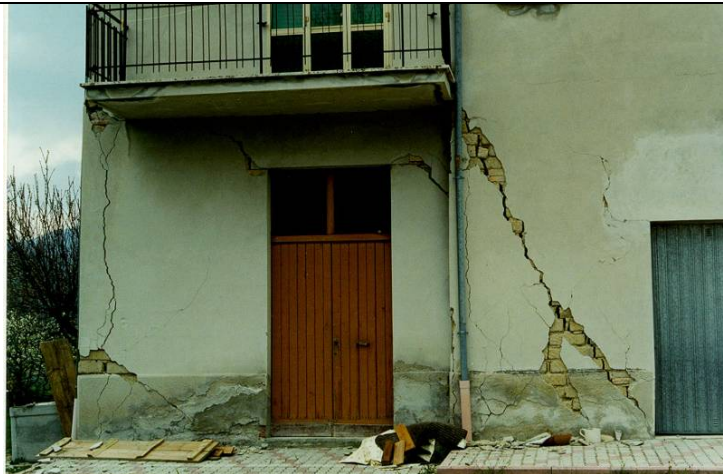
Fig. 4.21

Diagonal cracks (type 3)
associated to an out of plane
overturning failure mode, with
considerable out of plumb.
Damage grade: D4

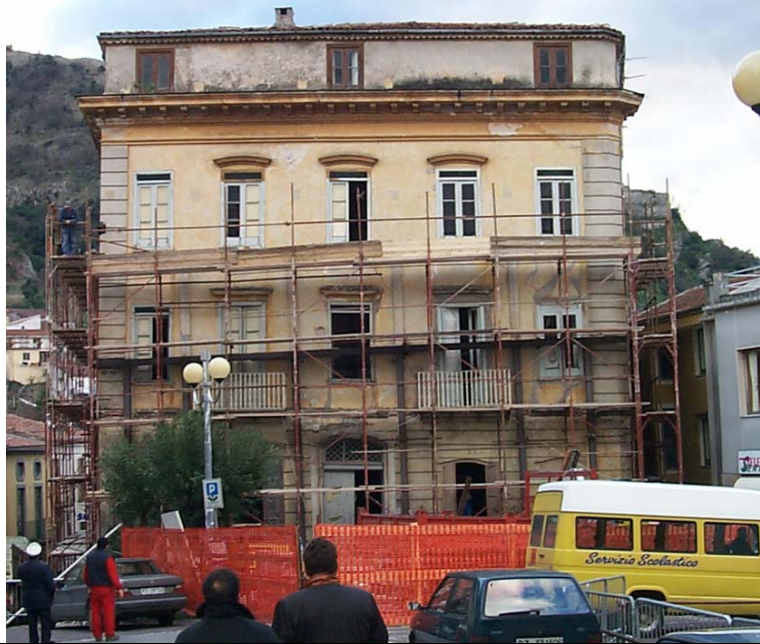
Fig. 4.24

Partial collapse of masonry walls and roof.

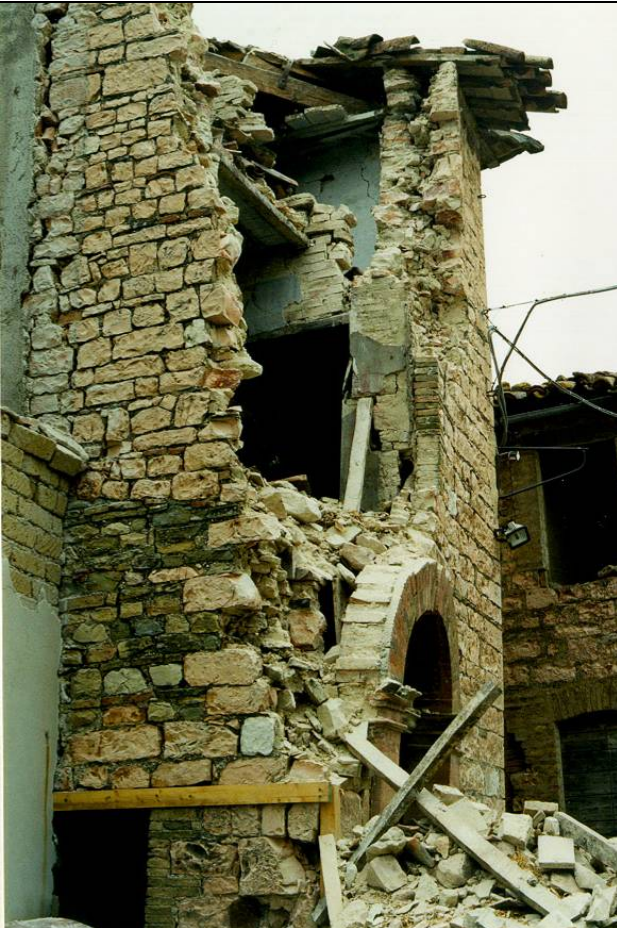
Fig. 4.25
Partial collapse of the roof
made of reinforced concrete
joists and hollow clay tiles
without slab.
Damage grade to the roof: D4-
D5

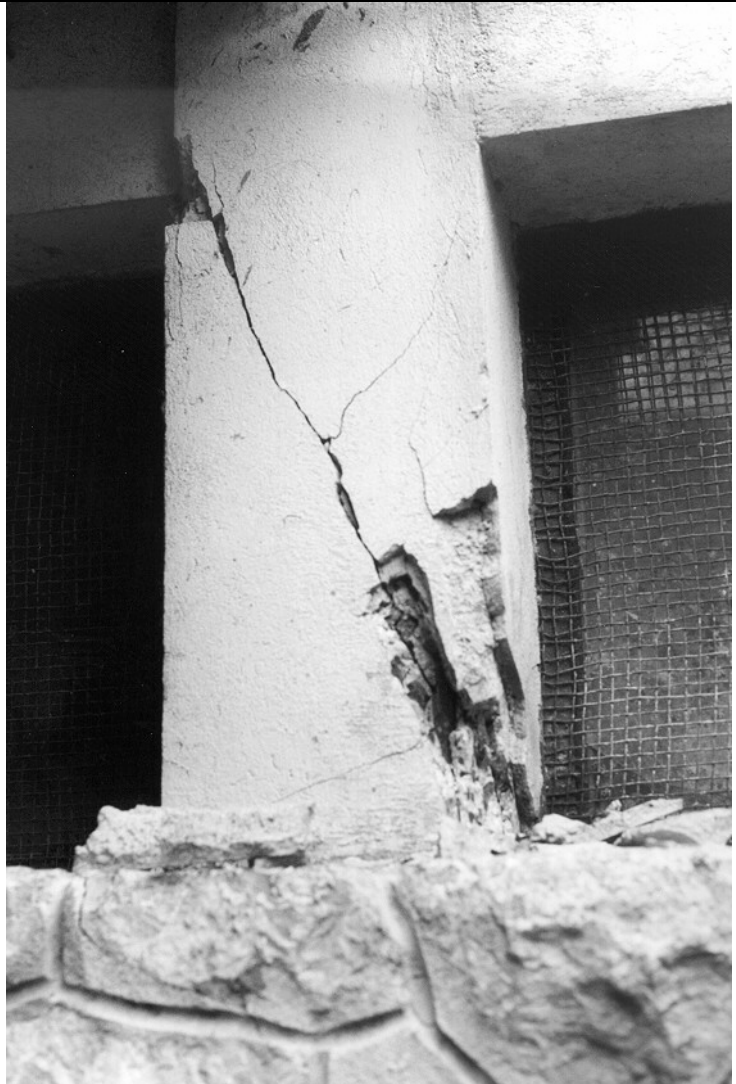
Fig. 4.27
Cracks in several
columns, facilitated by
oxidation of the
reinforcement.
Insufficient stirrups.
Total damage grade to
vertical structures: D2-
D3
(Fabriano, 1997)

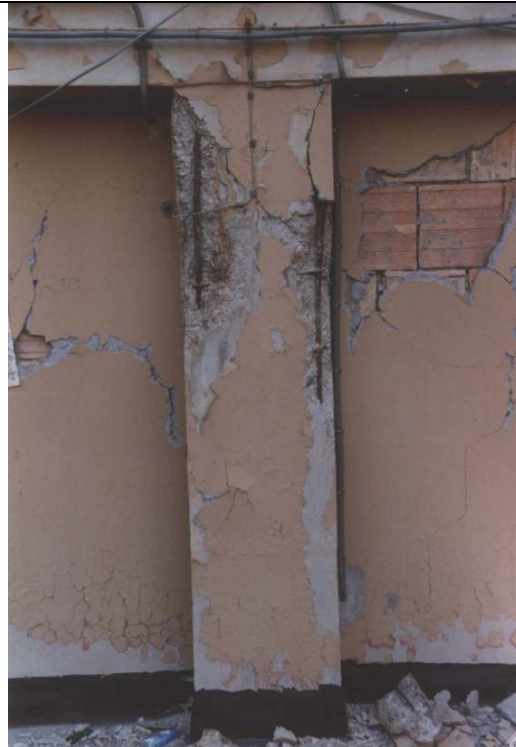
Fig. 4.28
Concrete spalling at the
column top section,
slight vertical cracks.
Damage grade: D2-D3
(Bagnolo, RE, 1996)

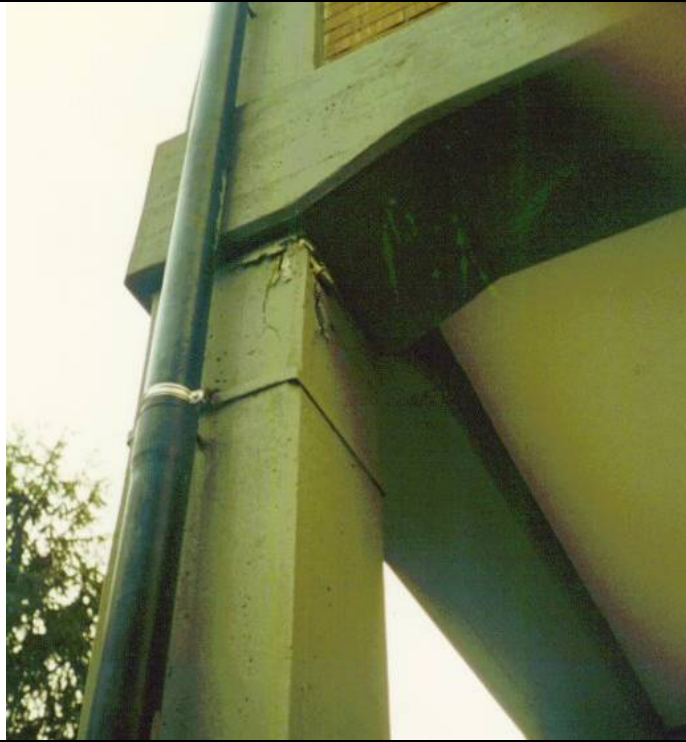
Fig. 4.29
Damage to the beam-
column joint with
concrete spalling.
Crushing of the infill
panel.
Damage level to vertical
structures: D4

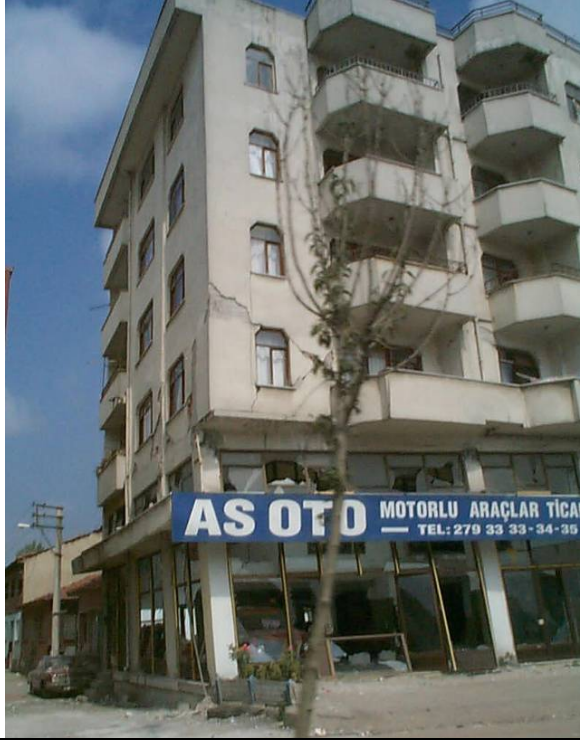
Fig. 4.31

Damage to the beam-column joint; concrete spalling, horizontal crack and onset of buckling of the reinforcement.

Damage grade to vertical structures: D3
(Fabriano, 1997)

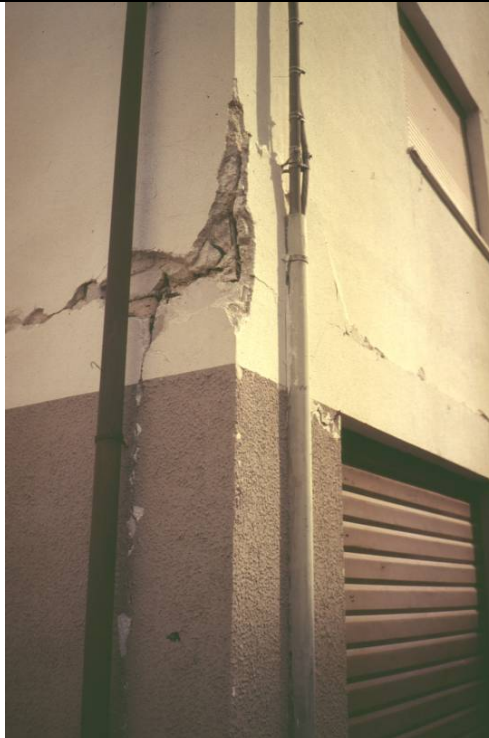
Fig. 4.32
Horizontal and vertical cracks to the infill panel, causing separation from the RC structure; partial collapse of the infill panel between the two doors.
Damage grade to infills: widespread D2, locally D4.
(Castelluccio Inferiore, PZ, 1998)

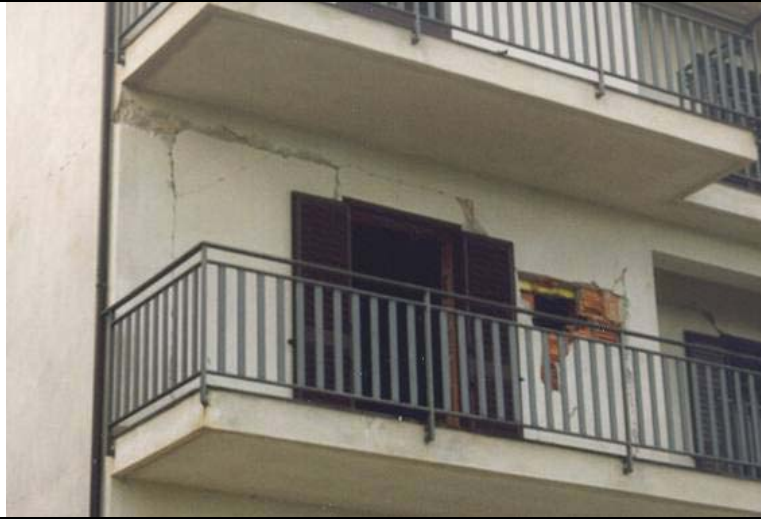
Fig. 4.33
Severe cracks in weak infills.
Damage grade to infills: D4
(Castelluccio Inferiore, PZ, 1998)

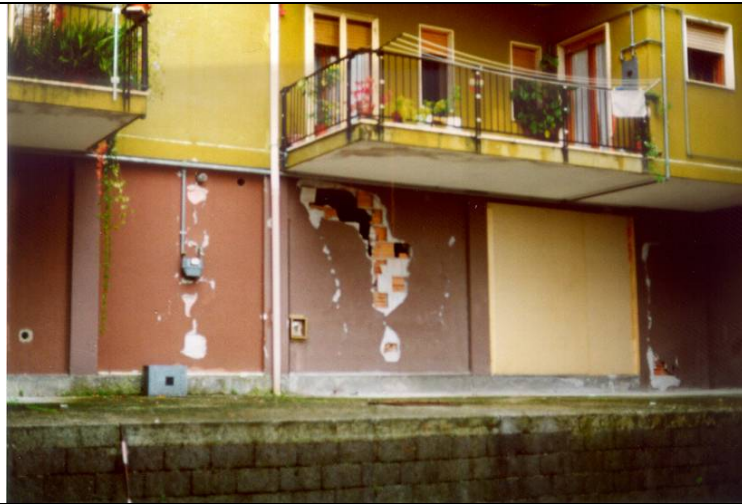
Fig. 4.34
Out of plane overturning
of brick hangings not
connected to the RC
structure.
Damage grade to infills:
D4
(Fabriano, 1997)

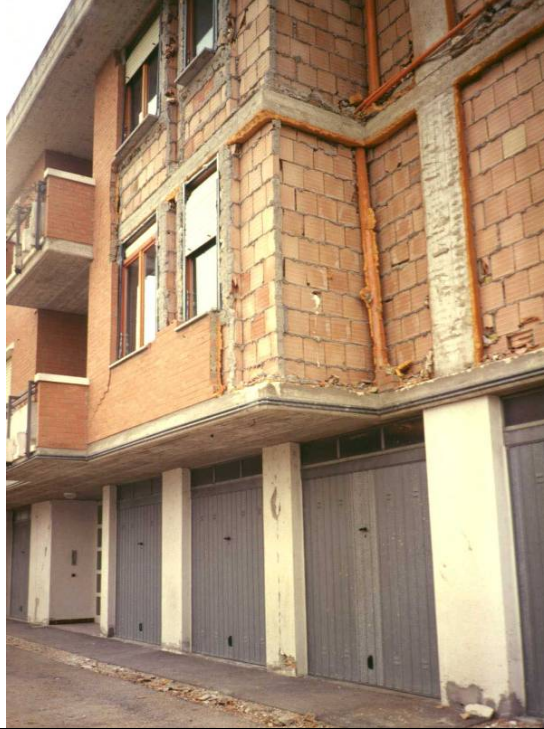
Fig. 4.35
Very heavy damage to a
reinforced concrete
framed structure, with
collapse of several
columns at the first and
second storey.
Damage grade: D4-D5
(Turkey, 1999)

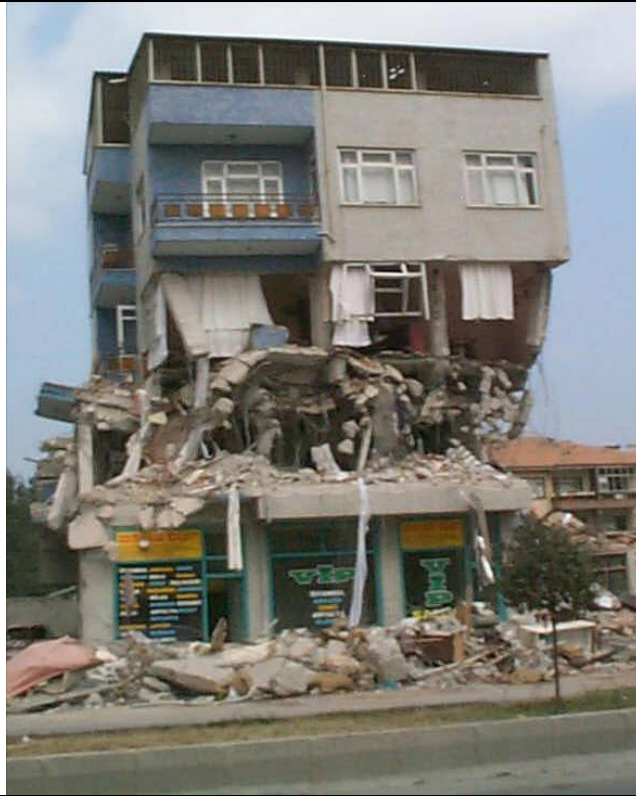
Fig. 4.36
Total collapse
(pancake) of a
reinforced concrete
building, similar to
the one under
construction in the
background.
Damage grade: D5
(Turkey, 1999)

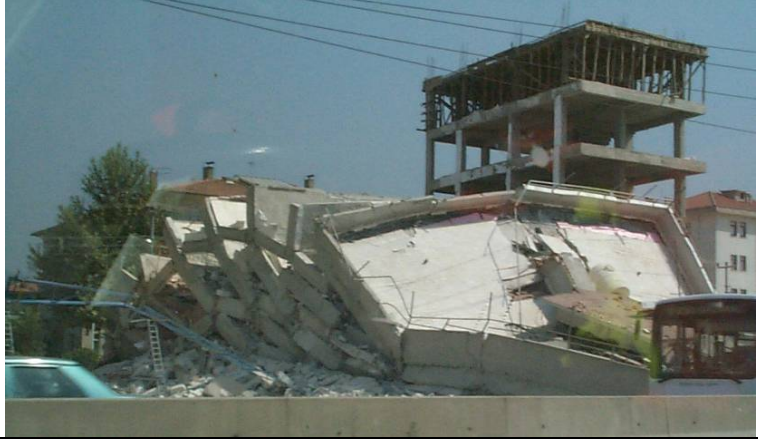
Fig. 4.37
Collapse due to soft
storey at the ground
floor.
Damage grade: D5
(Turkey, 1999)
